SH 36 Stream Conditions Assessment and Evaluation Report – Level 1

Brazoria and Fort Bend Counties, Texas

2020

Ecosystem Planning and Restoration, LLC

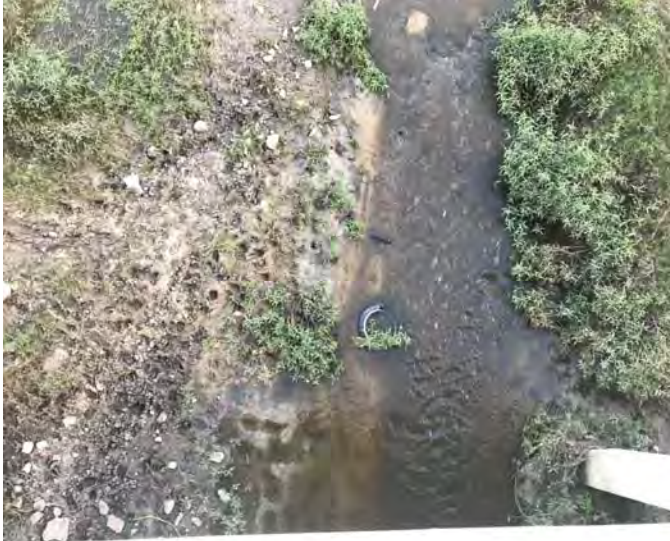
Notes: Bridge present and outside banks of stream. Cattle pressure present, degrading banks in portion via foot traffic. Does not appear to have access to floodplain.

REACH CONDITION INDEX and STREAM CONDITION UNITS FOR THIS REACH	
THE CONDITION INDEX (CI) >>	2.24

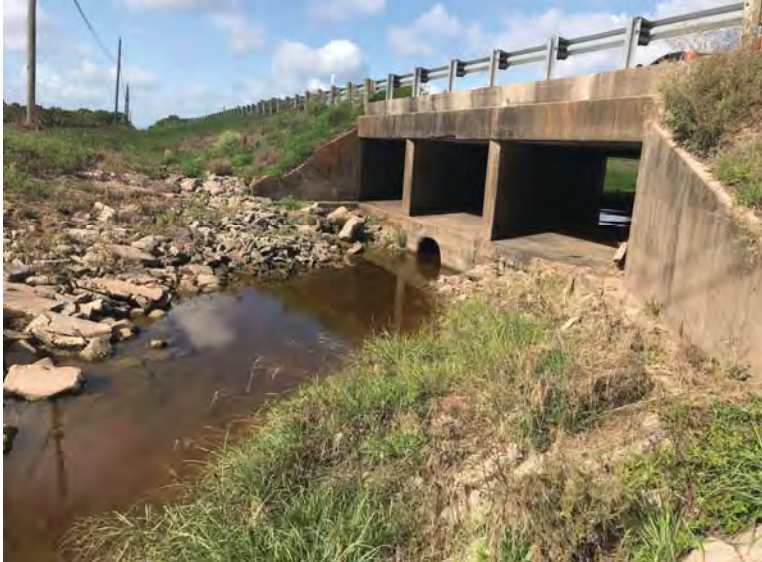
REACH CONDITION INDEX and STREAM CONDITION UNITS FOR THIS REACH	
THE CONDITION INDEX (CI) >>	1.61

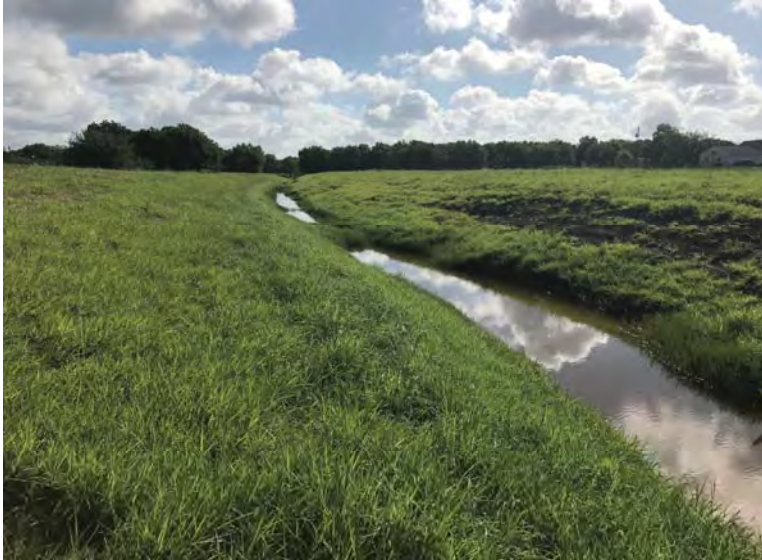
REACH CONDITION INDEX and STREAM CONDITION UNITS FOR THIS REACH	
THE CONDITION INDEX (CI) >>	2.00

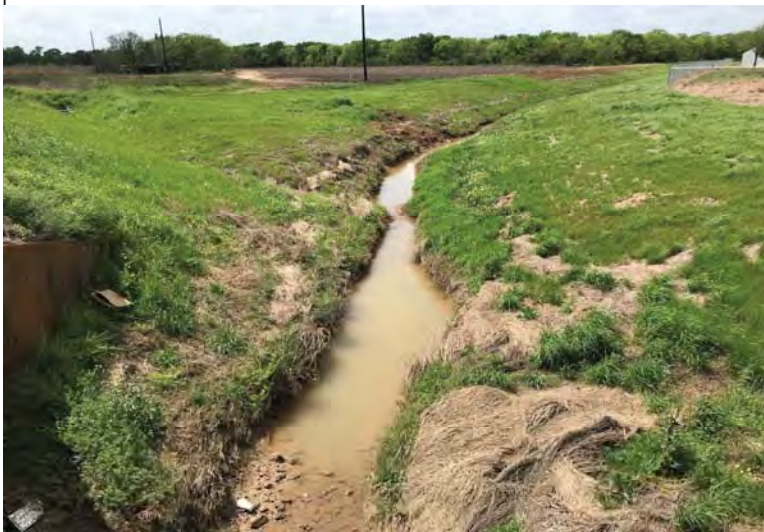
REACH CONDITION INDEX and STREAM CONDITION UNITS FOR THIS REACH	
THE CONDITION INDEX (CI) >>	1.53

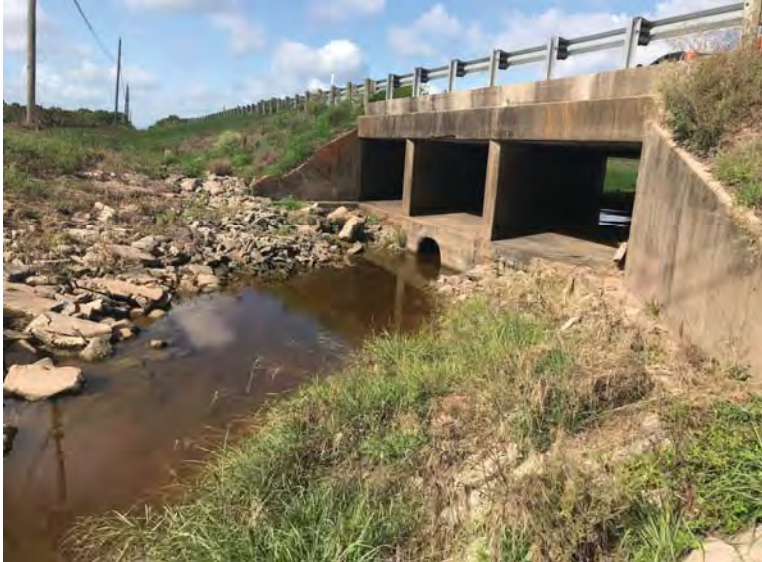
REACH CONDITION INDEX and STREAM CONDITION UNITS FOR THIS REACH	
THE CONDITION INDEX (CI) >>	1.61

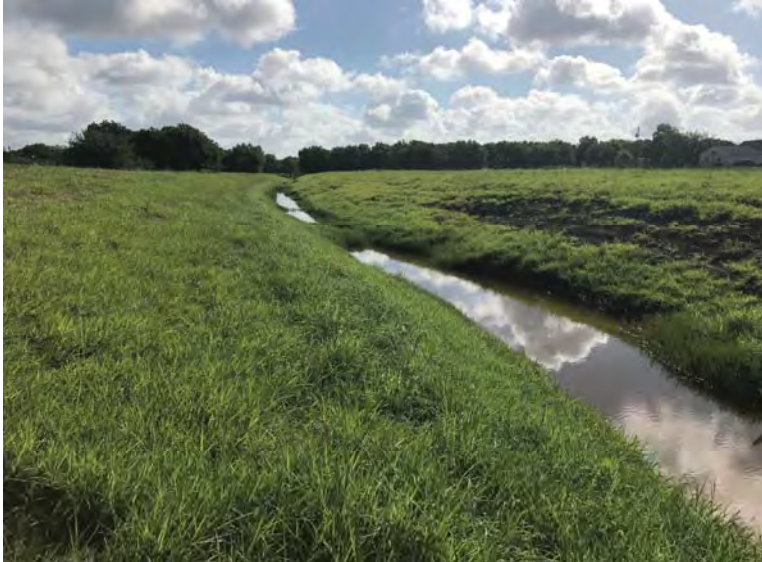
REACH CONDITION INDEX and STREAM CONDITION UNITS FOR THIS REACH	
THE CONDITION INDEX (CI) >>	2.00

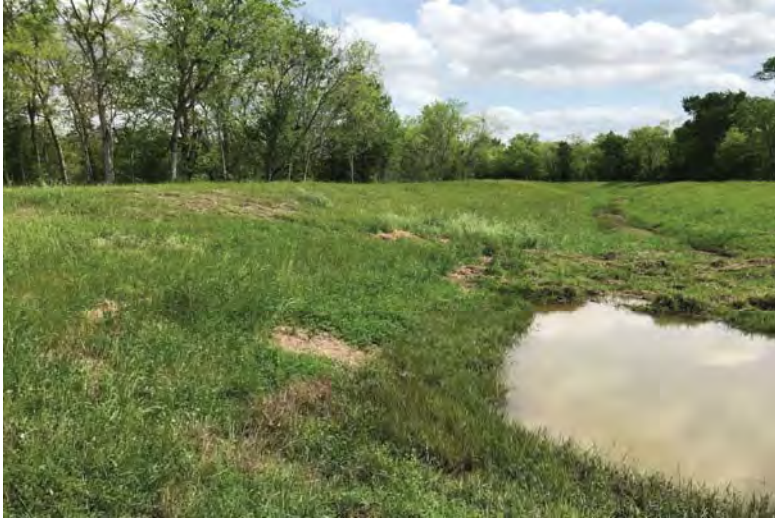
REACH CONDITION INDEX and STREAM CONDITION UNITS FOR THIS REACH	
	THE CONDITION INDEX (CI) >> 2.77

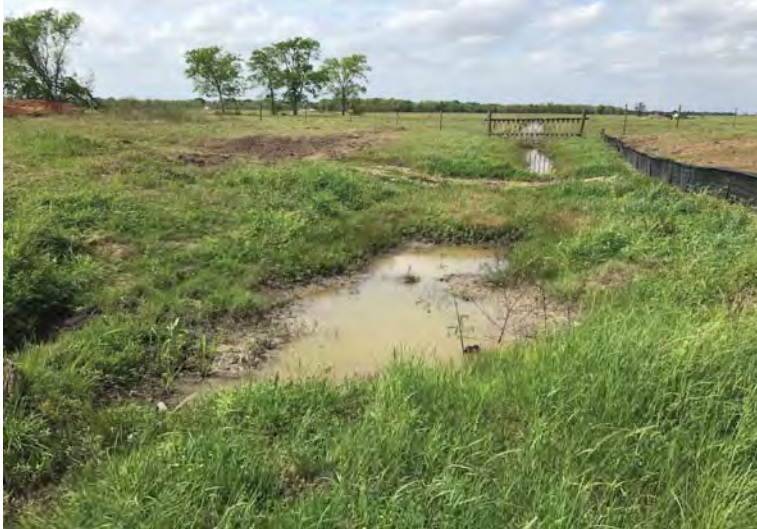
REACH CONDITION INDEX and STREAM CONDITION UNITS FOR THIS REACH	
THE CONDITION INDEX (CI) >>	2.00

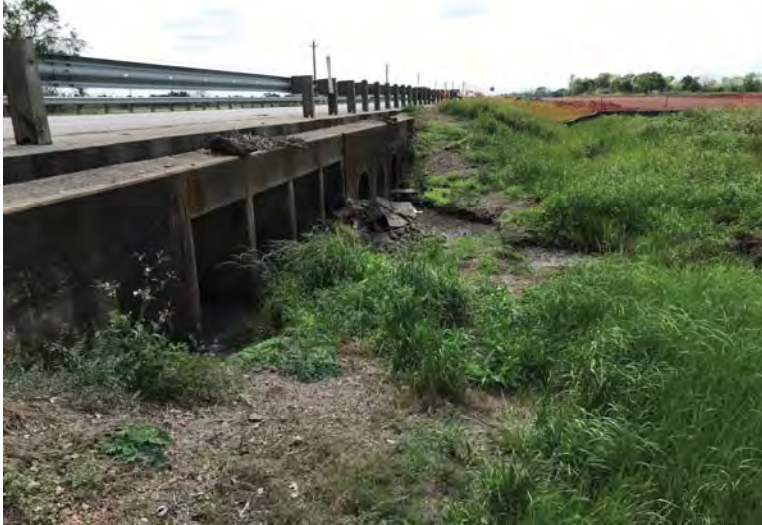
REACH CONDITION INDEX and STREAM CONDITION UNITS FOR THIS REACH	
THE CONDITION INDEX (CI) >>	1.91

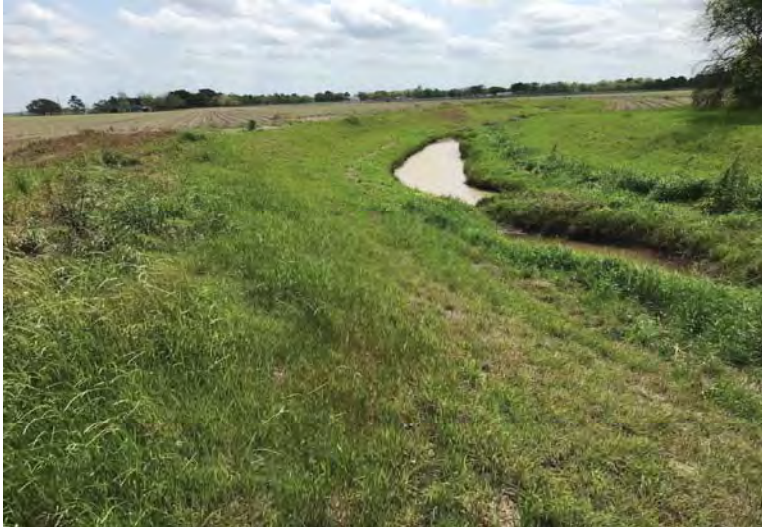
REACH CONDITION INDEX and STREAM CONDITION UNITS FOR THIS REACH	
THE CONDITION INDEX (CI) >>	1.82

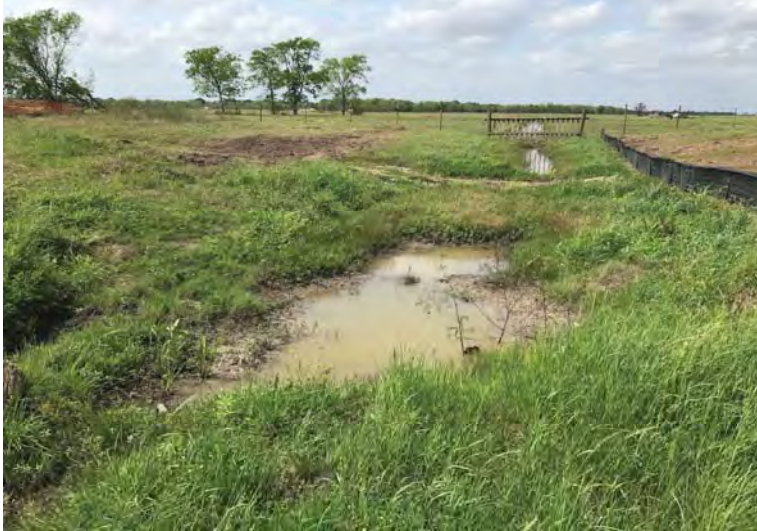
REACH CONDITION INDEX and STREAM CONDITION UNITS FOR THIS REACH	
THE CONDITION INDEX (CI) >>	1.63

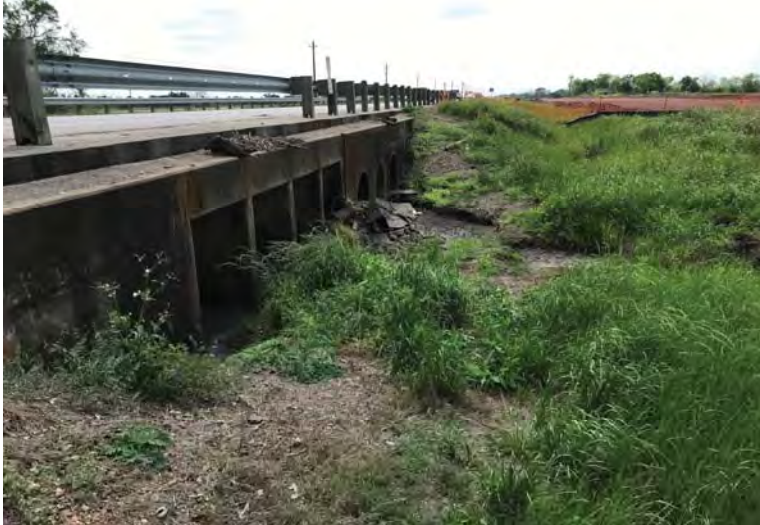
REACH CONDITION INDEX and STREAM CONDITION UNITS FOR THIS REACH	
THE CONDITION INDEX (CI) >>	1.88

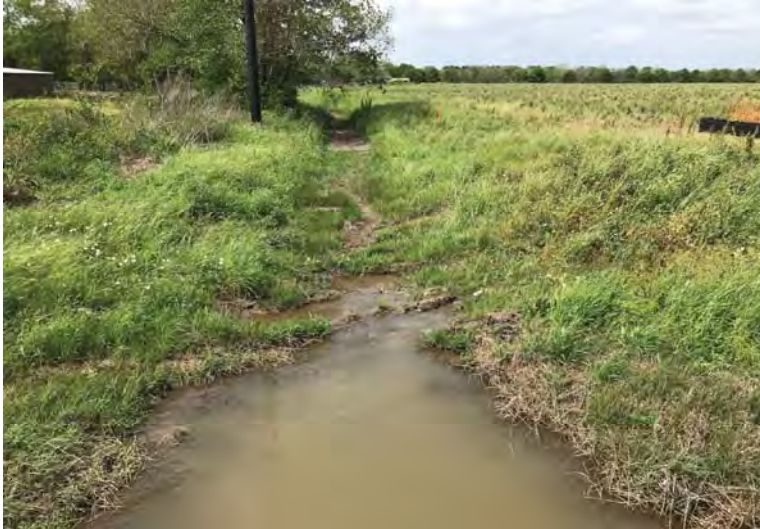
REACH CONDITION INDEX and STREAM CONDITION UNITS FOR THIS REACH	
THE CONDITION INDEX (CI) >>	1.58

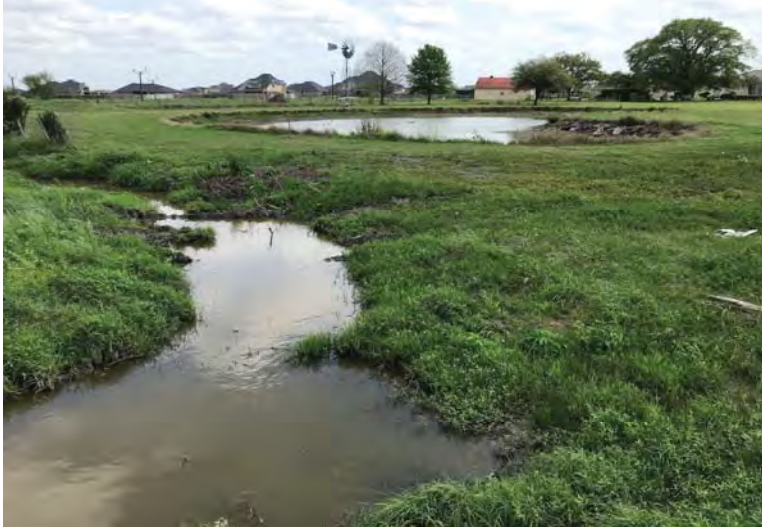
REACH CONDITION INDEX and STREAM CONDITION UNITS FOR THIS REACH	
THE CONDITION INDEX (CI) >>	1.74

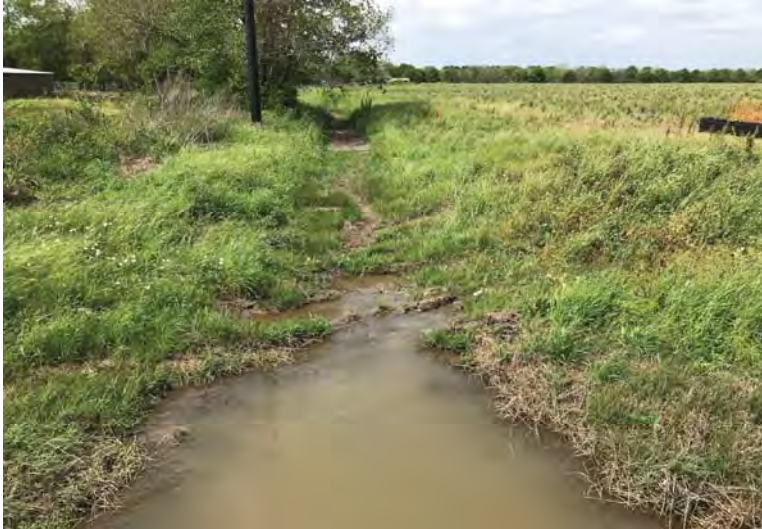
REACH CONDITION INDEX and STREAM CONDITION UNITS FOR THIS REACH	
THE CONDITION INDEX (CI) >>	1.38

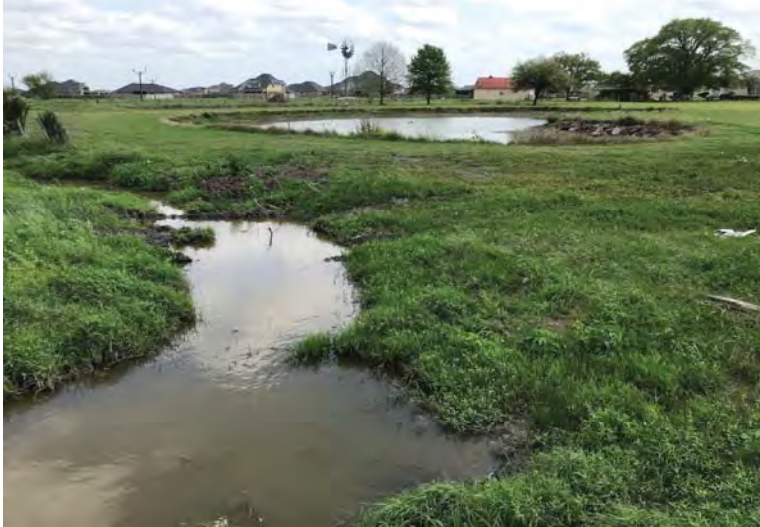
REACH CONDITION INDEX and STREAM CONDITION UNITS FOR THIS REACH	
THE CONDITION INDEX (CI) >>	1.38

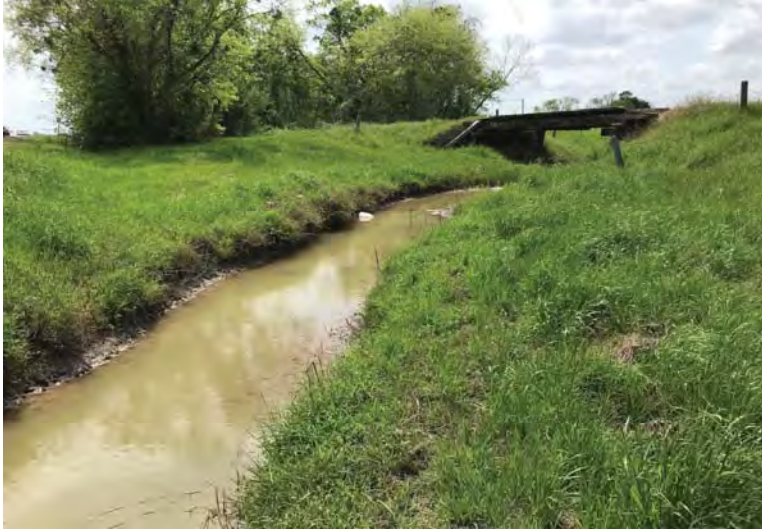
REACH CONDITION INDEX and STREAM CONDITION UNITS FOR THIS REACH	
THE CONDITION INDEX (CI) >>	1.90

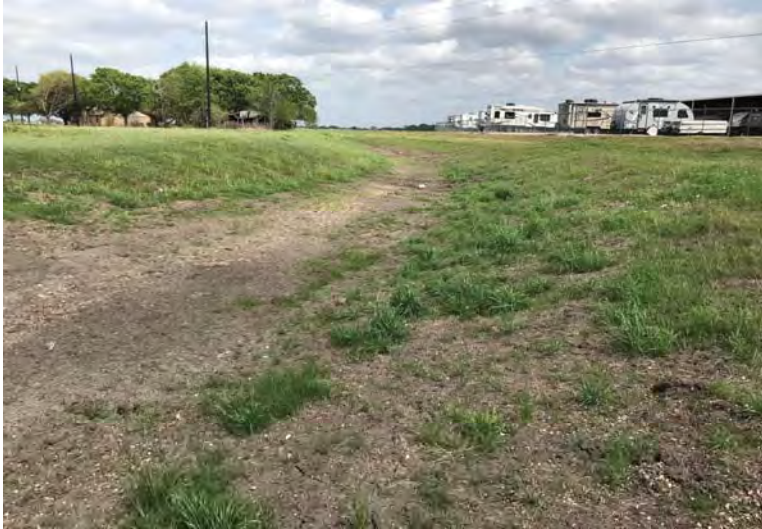
REACH CONDITION INDEX and STREAM CONDITION UNITS FOR THIS REACH	
THE CONDITION INDEX (CI) >>	1.98

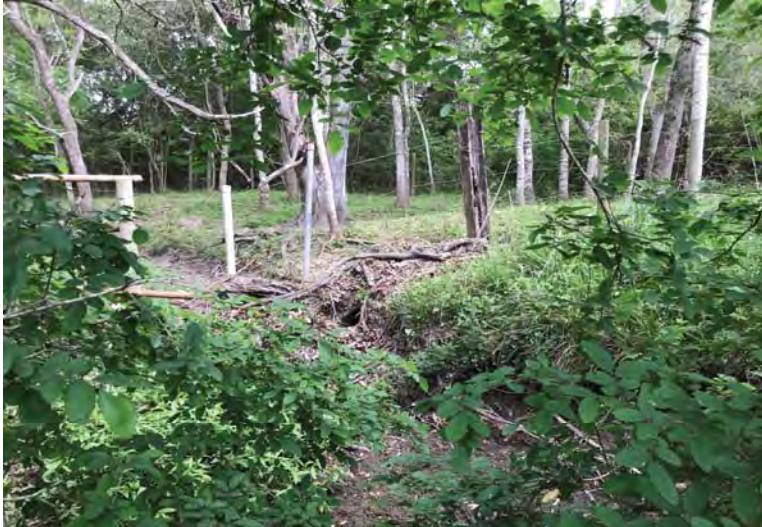
REACH CONDITION INDEX and STREAM CONDITION UNITS FOR THIS REACH	
THE CONDITION INDEX (CI) >>	3.31

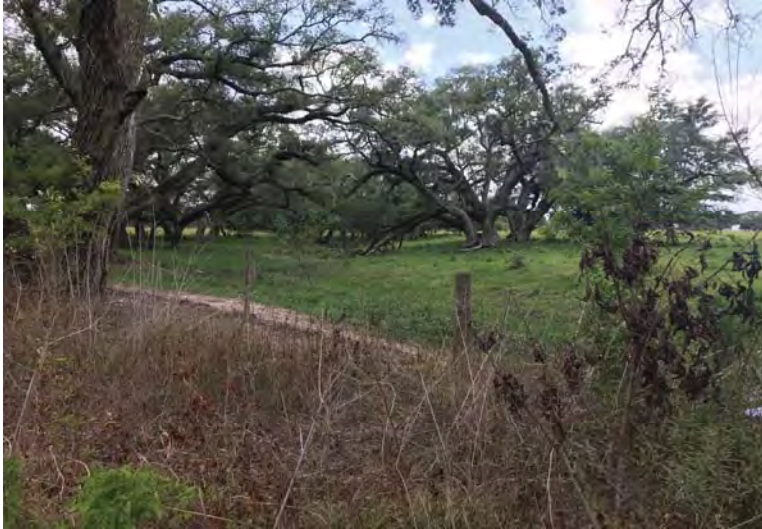
REACH CONDITION INDEX and STREAM CONDITION UNITS FOR THIS REACH	
THE CONDITION INDEX (CI) >>	1.26

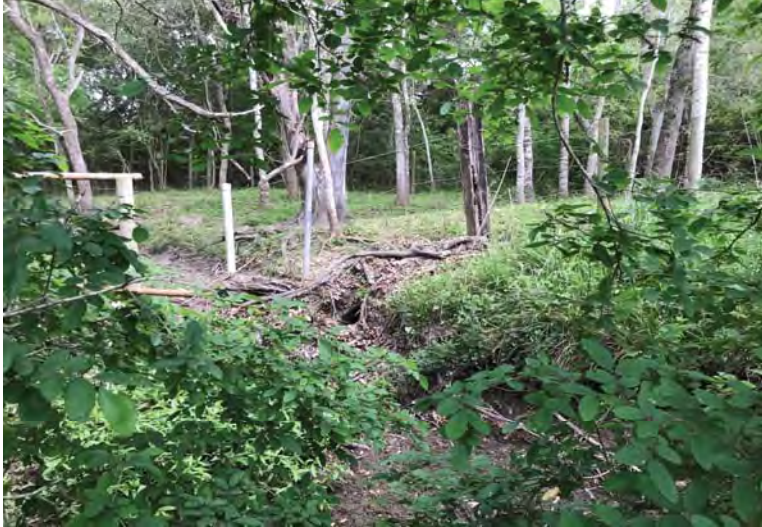
Notes: Construction is not proposed for this transect. Because of extense conversion upstream, the condition of the channel downstream likely to be impacted.

REACH CONDITION INDEX and STREAM CONDITION UNITS FOR THIS REACH	
THE CONDITION INDEX (CI) >>	3.06
